he Viper X-15 from Bluegrass Armory is one of a few new fifties on the market trying to carve out a niche for itself. Since it has only been available since 2002, I suspect many of you may not be familiar with it as of yet. While a more extensive evaluation is in the works for a forthcoming edition, the primary focus of this article will be the review of an interesting video clip of the Viper that's been circulating on the Internet. If you have access to the Web this video is definitely worth the download. It can be found at: http://www.bluegrassarmory.com

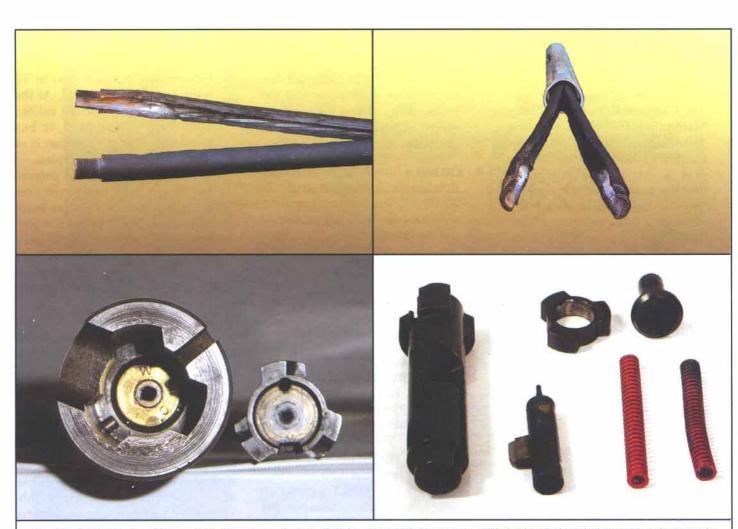
Top: right & left; results of the sand filled bore test. Bottom: Bolt face view; While the case is still lodged in the barrel, the primer etched into the bolt face from heat and pressure. Bolt component view: The bolt and related parts after plugged bore test. All major components were unharmed except for the firing pin spring which was permanenlty compressed by the gas flow back through the bolt.

Since the mud test didn't result in failure, the barrel was then filled and packed with sand in order to provide a more strenuous assessment. Upon firing the barrel did indeed rupture and nearly spilt its entire length, yet the rest of the firearm remained unscathed.

So what happened you ask? Upon firing, the bullet slammed into the first setscrew then transferred its energy to the outermost setscrew, which then flew out of the barrel leaving the bullet captive. The brass remained in the chamber, but the pressure and heat burned out the primer pocket, which pushed the firing pin back in the bolt crushing the substantial firing pin spring. The gas then escaped through the bottom of the trigger guard. Amazingly the bolt and receiver held. The Viper is one tough rifle!
